MASSERANN TECHNIQUE ENHANCES THE QUALITY OF TREATMENT-A CASE REPORT

ABSTRACT The incidence of fractured posts confronts the endodontically treated tooth a hopeless prognosis. Removal of such posts can likely to cause damage since the roots are brittle. Masserann developed and designed an instrument for extracting posts or rigid instruments that are broken deeply within the roots with minimum damage. The case report presented here is about the successful retrieval of separated post wedged in root canal dentin of upper central incisor along with its post endodontic management.

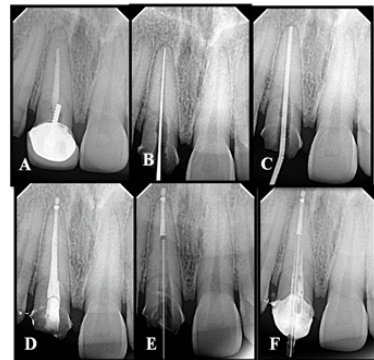
Fig. 1.

A-Preoperative Rvg Shows Metal Post With Improper Obturation;
B-Working Length Determination;
C-Master Cone;
D-Obturation;
E- Before Fiber Reinforced Post Luting F- After Fiber Reinforced Post Luting.

On clinical examination, 11 were found to be metal ceramic crown with tender on percussion and Ellis II fracture in 12. Vitality test gave a negative response in relation to 11 and positive response in relation to 12, 21 and 22. An Intra Oral Periapical Radiograph (IOPA) in relation to 11 revealed improper obturation of root canal and post placement (Fig. 1A) & (Fig. 2A).

Metal ceramic crown is removed carefully; metal post is retrieved using Masserann post retrieval kit. Obturation material was removed completely, working length determined follow by cleaning and shaping of the canal till size 60 K-file followed by step back till size 80 K-file. (Fig. 1B-C). Repeated calcium hydroxide dressings were given at an interval of 5 days for 1 month. Obturation was done using cold lateral compaction technique. After 1 week of post obturation, post preparation was done and fiber reinforced post was placed followed by composite core build up (Fig. 1D, E, F). (Fig. 2B).

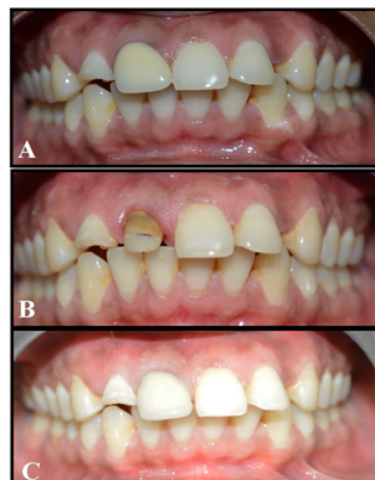
Fig. 2.

A-Preoperative labial view;
B-Fiber reinforced post with dual cure composite resin;
C-post operative labial view after crown luting.

Crown preparation was done using tapered fissure bur followed by putty impression was taken. VITA shade guide was used to evaluate the proper shade guide. Crown luting was done using Type II luting glass ionomer cement. (Fig. 2C).
